Manhole Inspection Summary

Manhole # S15C1_009MH

Insp Date: **5/27/08 8:21 AM**

Location Address: **1711 casadel av**

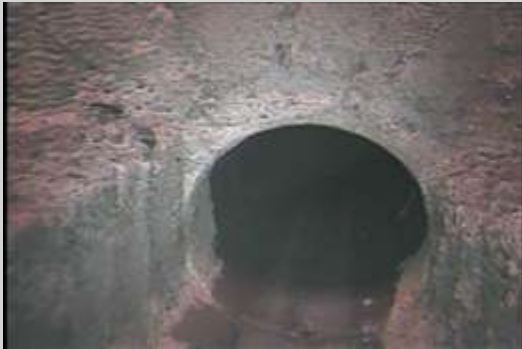
12 O'Clock Outflow

8 in. Circular Gravity Sewer
Pipe Out @ 12 O'Clock

Pipe Height: **8.4** (in.) Rod and Bar (Angled)
Pipe Material: **Clay** ☐ Pipe Lined
Invert Depth: **8.00** (ft.) Flow Characteristics: **Slow**
Deposits: ☒ None ☐ Mud ☐ Sludge ☐ Debris ☐ Grease
Silt Depth: **0** (in.) Deposits Extent:
Infiltration: **None** Pipe Seal Cond: **Sound**

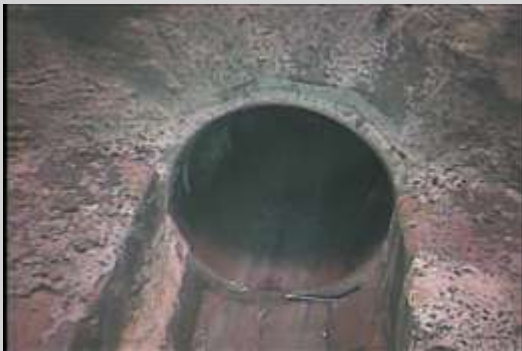
6 O'Clock Inflow

8 in. Circular Gravity Sewer
Pipe In @ 6 O'Clock

Pipe Height: **8.4** (in.) Rod and Bar (Angled)
Pipe Material: **Clay** ☐ Pipe Lined
Invert Depth: **7.00** (ft.) Flow Characteristics: **Slow**
Deposits: ☒ None ☐ Mud ☐ Sludge ☐ Debris ☐ Grease
Silt Depth: **0** (in.) Deposits Extent:
Infiltration: **None** Pipe Seal Cond: **Sound**
